RAILWAY INVESTIGATION REPORT
R00D0098

COLLISION AND DERAILMENT

VIA RAIL CANADA INC.
TRAIN NO. 603
MILE 119.35, LA TUQUE SUBDIVISION
LA TUQUE, QUEBEC
30 AUGUST 2000

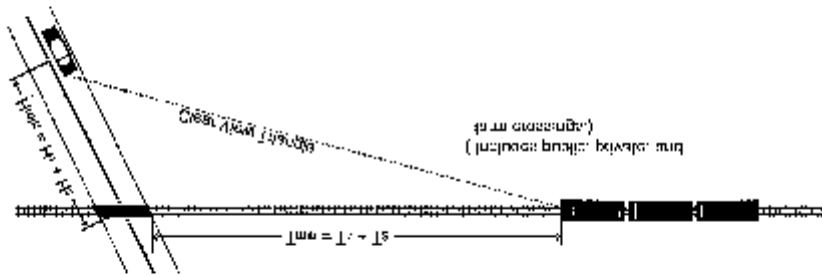
Figure 1-8 - Minimum Sight Lines at All Crossings Without a Warning System

As the sight-line is 180 m and the train covers that distance in 8 seconds, a vehicle like the one involved in the accident, stopped at the stop sign, would take approximately 9 seconds to accelerate and pass over the crossing. Accordingly, if the driver stopped at the stop sign before passing over the crossing, checked to see that the track was free and then drove on, he would have had just enough time to pass over the crossing or the locomotive would have hit the rear of the truck. However, as the truck was struck in the front, as shown by the damage on the locomotive, the driver might have been surprised by the sudden arrival of the train and stopped accelerating while passing over the crossing, or the truck entered the crossing without observing that a train was approaching. On the other hand, the simulation revealed that, at a distance of 8 m from the crossing, the truck driver's left rearview mirror created a blind spot that partly obstructed the driver's view and could have prevented him from seeing the oncoming train. Accordingly, the driver might have looked to his left, not seen the train and therefore continued to advance towards the crossing thinking that the track was free. However, in view of the absence of an event recorder memory module on the truck and of the lack of information about the truck driver's manoeuvres on approaching the crossing, the course of the events leading up to the accident cannot be reconstructed with certainty, and similar accidents thus be prevented.
